Manhole Inspection Summary

Manhole # S63M__003MH

Insp Date: **4/25/08 11:40 AM**

Location Address: **5501 O'Donnell St.**

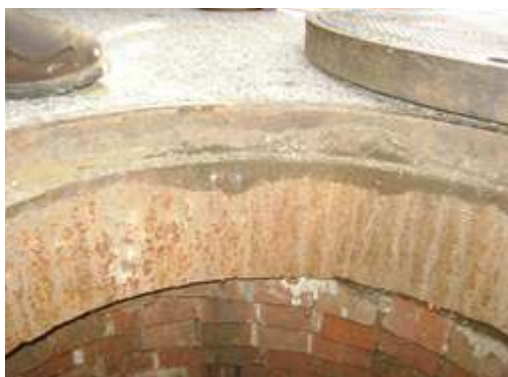
Defect 3

Condition: ☐ Sound ☐ Cracked ☐ Root Intrusion ☒ **Loose Brick** ☐ Deteriorated

Infiltration: ☐ None ☒ **Joint** ☐ Cracks ☒ **Mortar** ☐ Roots ☐ Wall

Loose Bricks

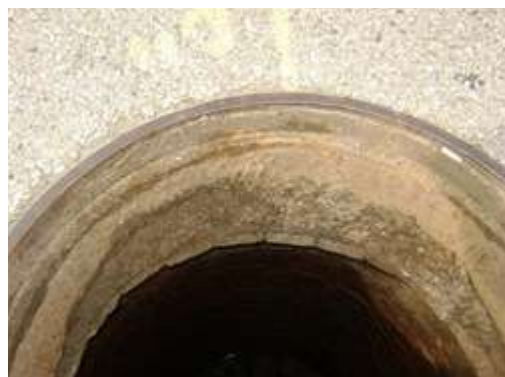
Defect 1

Frame Offset: **3** (in.) Condition: ☒ Sound ☐ Cracked ☐ Leaks

frame offset

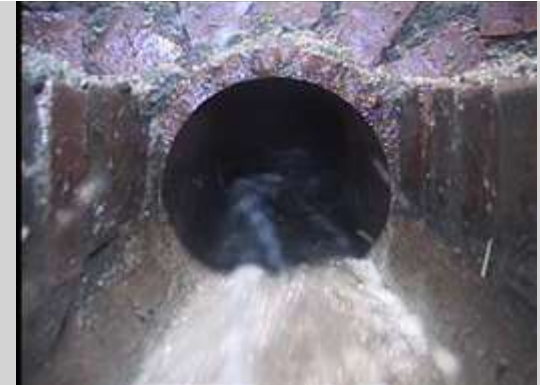
12 O'Clock Outflow

8 in. Circular Gravity Sewer
Pipe Out @ 12 O'Clock

Pipe Height: **8.4** (in.) Rod and Bar (Angled)
Pipe Material: **Clay** ☐ Pipe Lined
Invert Depth: **10.75** (ft.) Flow Characteristics: **Fast**
Deposits: ☒ None ☐ Mud ☐ Sludge ☐ Debris ☐ Grease
Silt Depth: (in.) Deposits Extent:
Infiltration: **None** Pipe Seal Cond: **Sound**

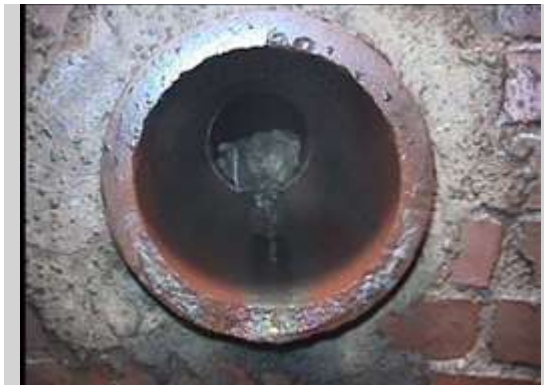
6 O'Clock Inflow

8 in. Circular Gravity Sewer
Pipe In @ 6 O'Clock

Pipe Height: **8.4** (in.) Rod and Bar (Angled)
Pipe Material: **Clay** ☐ Pipe Lined
Invert Depth: **8.25** (ft.) Flow Characteristics: **Fast**
Deposits: ☒ None ☐ Mud ☐ Sludge ☐ Debris ☐ Grease
Silt Depth: (in.) Deposits Extent:
Infiltration: **None** Pipe Seal Cond: **Sound**

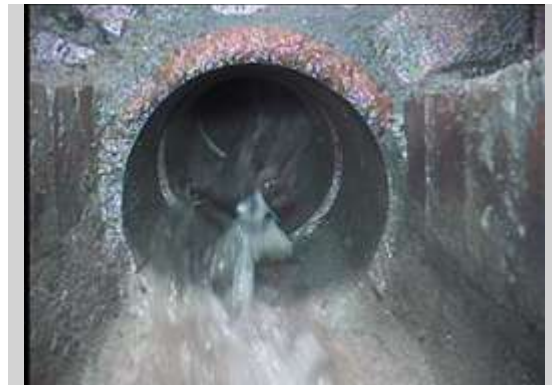
Drop In @ 6 O'Clock

Drop: **Outside** Rod and Bar
Angled: **Yes** Reading: **9.67** (ft.)
Inv Depth: **10.67** (ft.)
Drop Condition: **Open**
